Thomas Enterprising

Property Inspection Report

123 Easy St , Viera FL, 32940
Inspection prepared for: Report Sample
Inspection Date: 8/10/2010 Time: 5:00PM
Age: 2004 Size: 3532 sq ft
Weather: Cloudy
1 Story Reinforced solid poured concrete

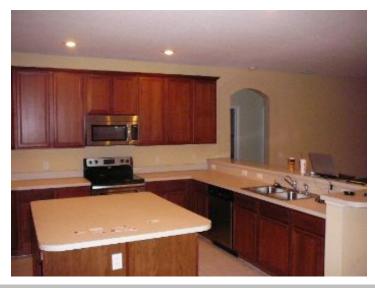
1. Cabinets

Base cabinet to the right of the stove is missing a hinge.

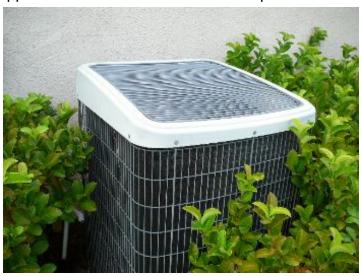
6. AC Compress Condition

Appeared functional at the time of inspection.

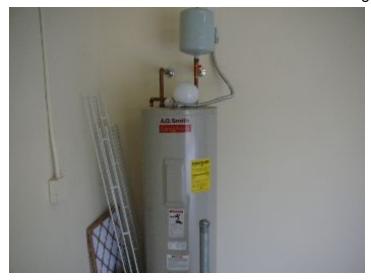
3. Water Heater Condition

Tank appears to be in satisfactory condition -- no concerns.

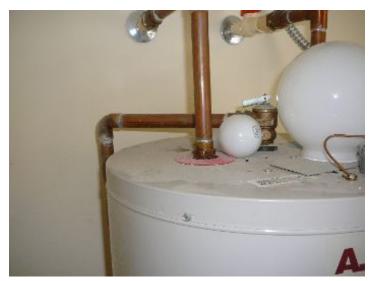
4. TPRV

Appears to be in satisfactory condition -- no concerns.

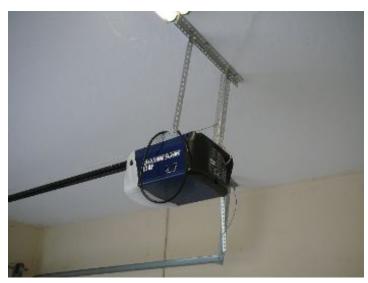
12. Garage Door Part	'S
Good Fair Poor N/A None	Observations:
X	• The garage door appeared functional during the inspection.
13. Garage Opener S	tatus
Good Fair Poor N/A None	Observations:
X	• Chain drive opener noted.

• The garage door opener is functional, safety features are built in. The single garage door does not have power going to it.

Chain drive opener noted.

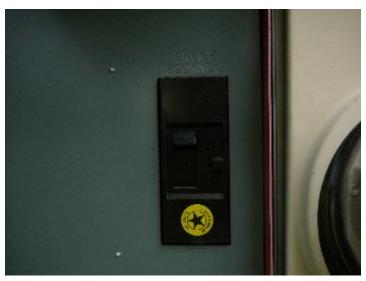
2. Main Amp Breaker

150 amp

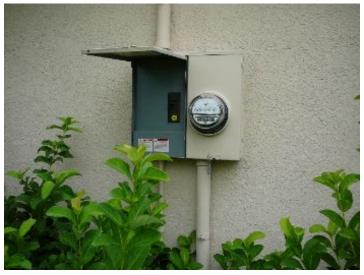
4. Cable Feeds

There is an underground service lateral noted.

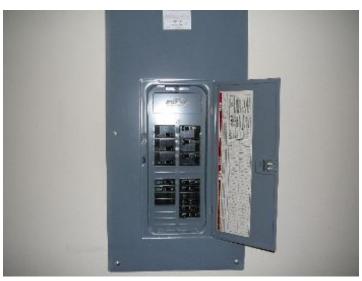
5. Breakers

All of the circuit breakers appeared serviceable.

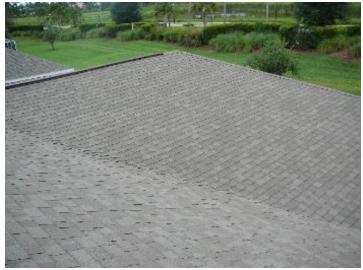
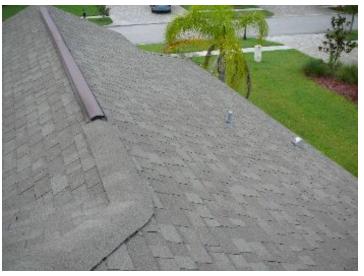
1. Roof Condition

No major system safety or function concerns noted at time of inspection.

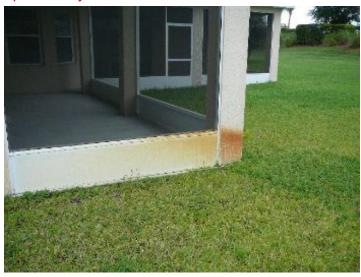
4. Exterior Paint

- Suggest caulking around doors and windows as necessary.
- Peeling paint observed, suggest scraping and painting as necessary.
- Paint on exterior shutters is beginning to get weathered and discolored due to sprinkler system.

Paint on exterior shutters is beginning to get weathered and discolored due to sprinkler system.

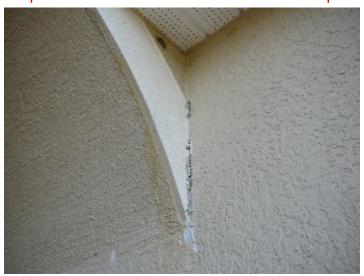
5. Stucco

The exterior stucco appears to numerous small cracks on the surface. Stucco is a paintable surface, and based on the condition we suggest doing so as paint can fill in the cracks and seal them up..

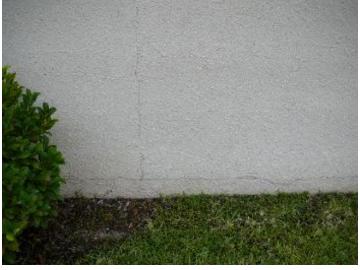
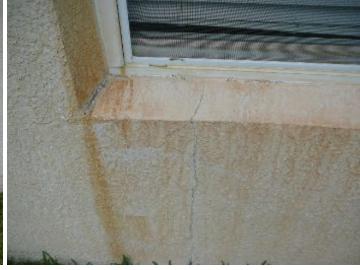
1. Slab Foundation

Cracks noted on the west exterior. Recommend consultation with qualified contractor to evaluate the condition of the foundation.

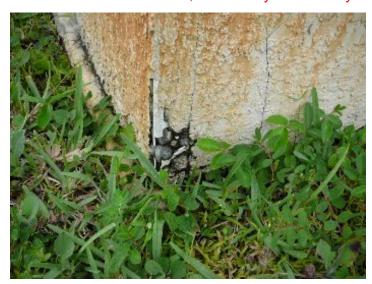
2. Foundation Perimeter

Common cracks observed, these may leak at any time.

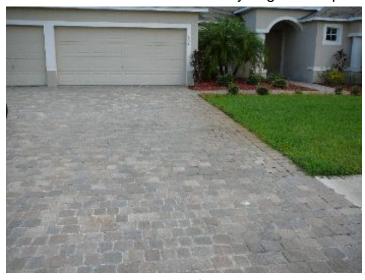
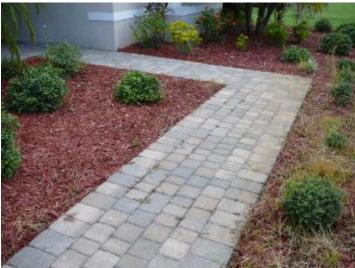
1. Driveway and Walkway Condition

Driveway in good shape for age and wear. No deficiencies noted.

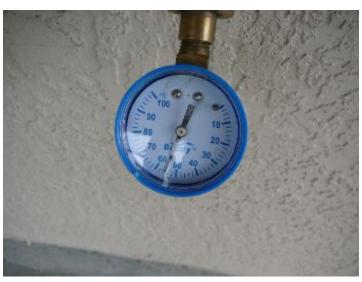
8. Water Pressure

55

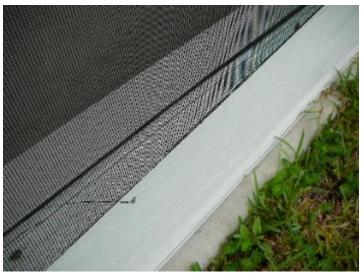
12. Patio Enclosure

Screen loose on east side of porch.

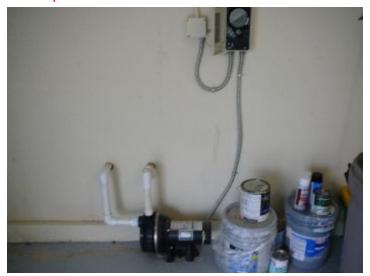
14. Sprinklers

- The sprinkler system operates with a control panel located in the garage.
- A few of the sprinkler heads are spraying structure. We recommend adjusting the heads so they do not spray the house.
- The inspector noted a few broken heads.

The sprinkler system operates with a control panel located in the garage.
